Article

Revealing the Corrosion Resistance of 316L Stainless Steel by an In Situ Grown Nano Oxide Film

Citation: Ren, Y.; Li, Y.; Shen, J.; Wu, S.; Liu, L.; Zhou, G. Revealing the Corrosion Resistance of 316L Stainless Steel by an In Situ Grown Nano Oxide Film. *Nanomaterials* **2023**, *13*, 578. <https://doi.org/10.3390/nano13030578>

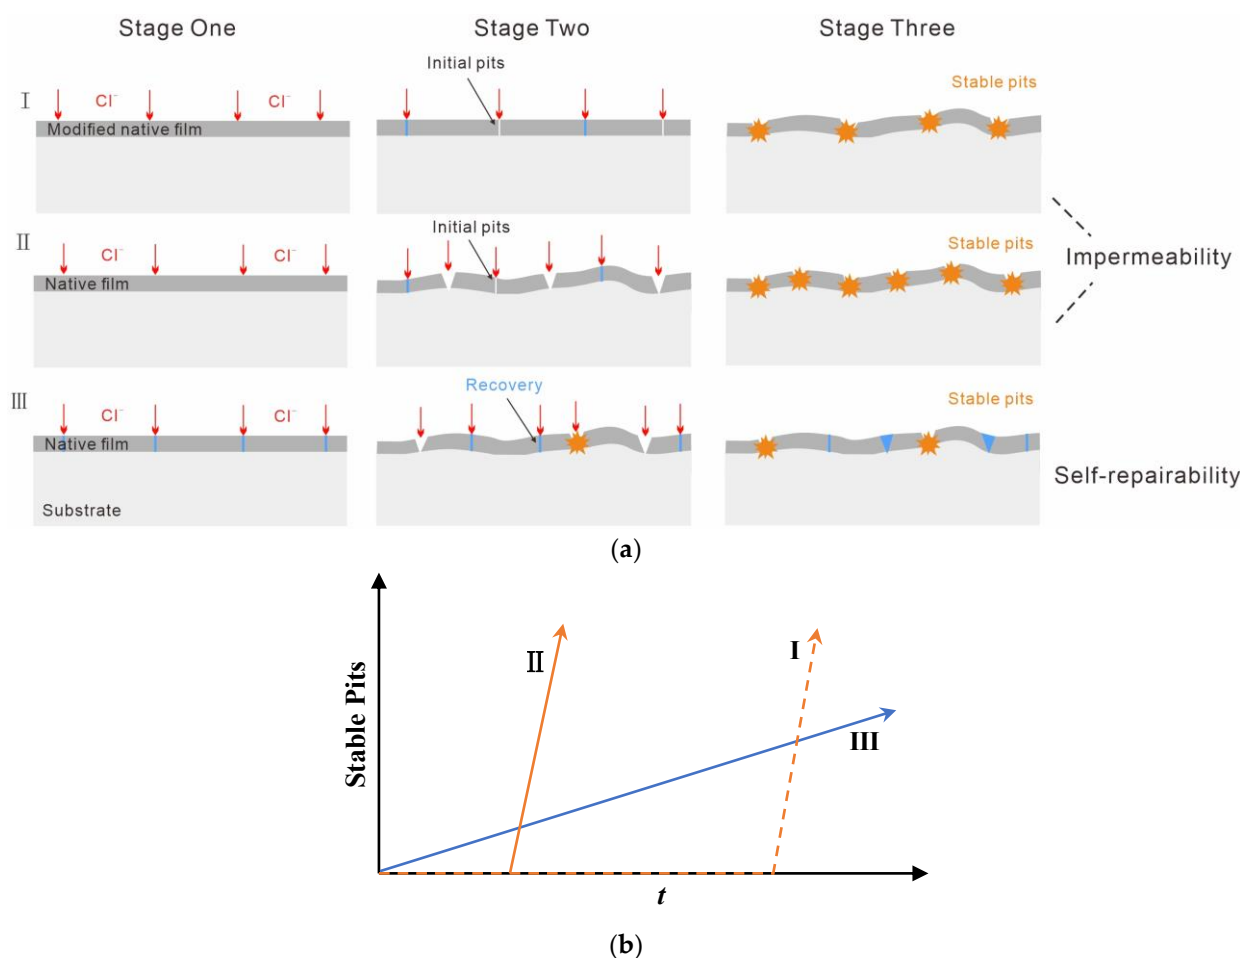
Figure 1. (a) Illustration of the determining dominant factors comparing the development of pitting: I, FE alloy with a typical impermeability-dominated corrosion resistance exhibits the least number of metastable pits at the initial stage due to the modified oxide film; II, Bare alloy with impermeability-dominated corrosion resistance, for which the native film can offer protection for a period; III, Bare alloy with a self-repairability-dominated corrosion resistance, in which metastable pitting occurs early but the stabilization of pits needs a long period of time. (b) The development of stable pits for each protection mechanism.

pits (I and II). Otherwise, if the number of metastable pits on the bare alloy at the initial stages (stage one and stage two) exceeds that of the FE alloy and the quantity of stable pits in the following stage (stage three) is not higher than that of the FE one, the corrosion resistance is assumed to be self-repairability-dominated (I and III). This means that the growth rate of stable pits on the bare alloy is much lower than that of the FE alloy due to a self-repairing property, and consequently there must be a crossover in the development of stable pits between the two (Figure 1b). For self-repairability-dominated protection (III), the film breakdown and metastable pitting occur early (see stage one in Figure 1a) because of the weak impermeability of the native passive film. However, stable pits develop slowly for this protection because few small pits can grow into stable large pits due to excellent self-repairability of the alloy surface [20].

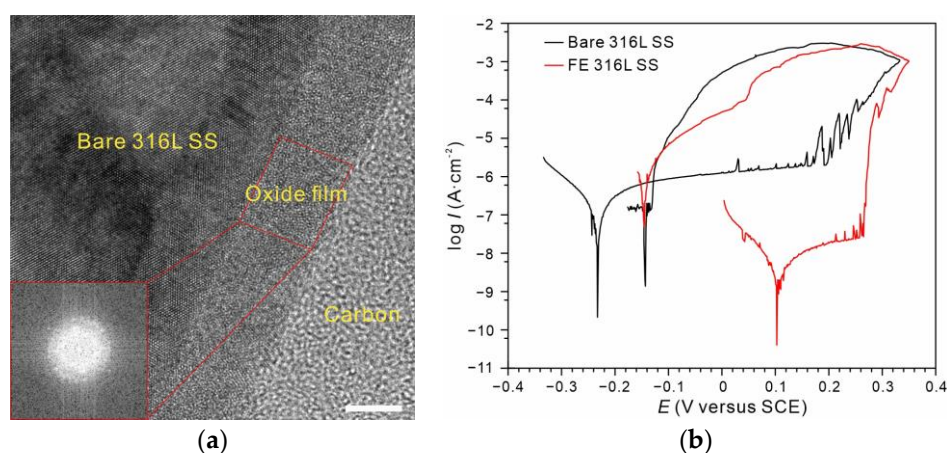
Figure 2. (a) Cross-sectional HR-TEM image of the modified oxide film on 316L SS (Scale bar, 5 nm). (b) Polarization curves of bare 316L SS (black) and FE 316L SS (red) with a reverse scan in 0.6 M NaCl solution (25 °C).

Figure 2a displays the cross-sectional high-resolution TEM image of the FE alloy. The increased thickness (~7.9 nm, and the native oxide film on 316L SS is ~3 nm) and amorphous structure on the (111) plane revealed by fast Fourier transform spectrum could be observed. The detailed characterization of the composition and structure of the thickened oxide film can be found in Ref [24]. The dynamic polarization curves revealed that the reverse scan for the FE alloy had returned exactly to the repassive potential of the native

film (~ -1.4 V) on the bare alloy, indicating that the reparability of the film was very weak and that the film can only be repaired by the native film. The enhanced protectiveness and long-term stability of the FE alloy were shown to be owing to a thickened continuous Cr_2O_3 layer (two to three nanometers) as well as the improved film quality [24]. Therefore, the corrosion resistance of the FE alloy was a typical impermeability-dominated protection. Such protection from robust ultrathin barriers or two-dimensional materials, such as graphene and borate nitride, has been reported recently [31–33]. However, these dissimilar materials would skip the metastable pitting and cause severe accelerated stable pitting once film breakdown occurs [26], which makes them unsuitable for studies of pitting comparison.

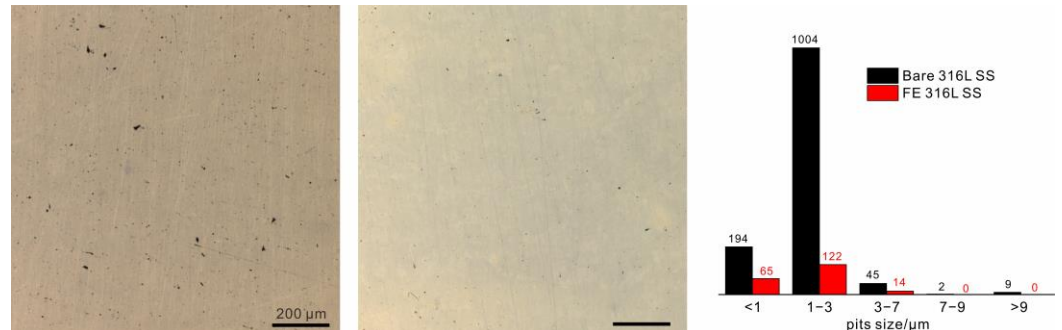
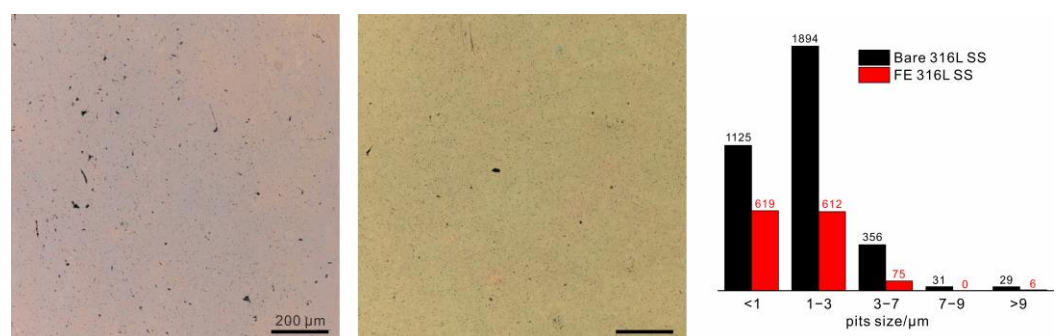
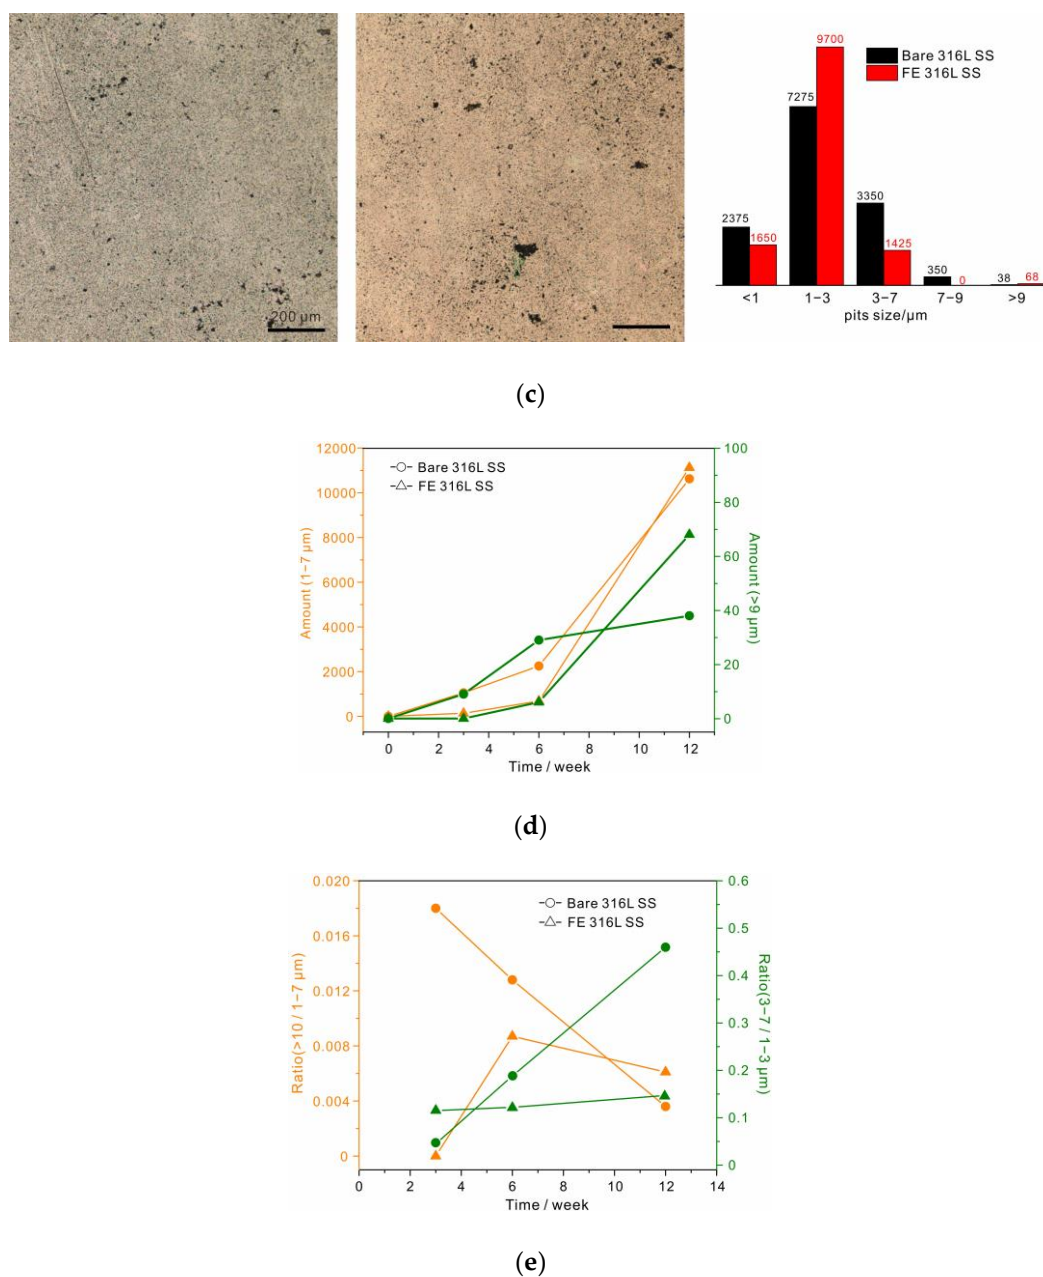
Figure 3. Optical microscopy photographs of 316L SS (left) and FE 316L SS (right) after immersion for (a) 3 weeks, (b) 6 weeks, and (c) 12 weeks, and the corresponding statistical results. (d) The development of metastable pits and stable pits, respectively. (e) The metastable-to-stable pit transformation ratio and the transformation ratio of metastable pits with small sizes (1–3 μm) to metastable pits with larger sizes (3–7 μm).

To observe the development of pitting, the samples were immersed in 1 M sodium chloride solution at 80 °C. An area of 1.2×1.2 mm² was selected to obtain accurate statistics, as shown in Figure 3. After 3 weeks, several stable pits (>9 μm in diameter) appeared on the bare alloy, and plenty of small metastable pits could also be observed. In contrast, stable pits on the surface of the FE alloy were hardly observed, and small metastable pits were also very scarce. The statistical results reveal that most of metastable pits were less than 3 μm in size, and the number of 1 to 3 μm pits on the bare alloy was about 8 times that on the FE alloy. After 6 weeks, several stable pits appeared on the FE alloy, and the number of metastable pits increased rapidly in this stage. While the quantity difference between the metastable pits in the two samples decreased, the number of stable pits on the bare alloy still exceeded that on the FE alloy. After 12 weeks, unexpectedly, the two samples were corroded to nearly the same degree. The statistical results revealed that the quantity of both metastable and stable pits on the FE alloy had increased more than ten times over the previous six weeks, which had far exceeded the increase on the bare alloy. Moreover, the newly formed stable pits on the bare alloy were few. These results clearly demonstrate that the anticorrosive oxide film could protect the alloy at the beginning stage of film breakdown (the first two stages). However, the protection was not so promising when film breakdown occurred frequently and it could not be well repaired. By comparison, the native film on 316L SS could slow down the development of both metastable and stable pits in the following weeks, revealing the key role of self-reparability in long-term corrosion resistance of 316L SS. It should also be noted that the development trends of pitting corrosion summarized in present study might not be applicable to other metals and alloys. As the chemical and structural stability of native passive film is dependent on the electrolyte, the repairing ability related to alloy composition is also influenced by the

electrolyte, and it may degrade and lead to rapid growth of stable pits in harsh conditions. Thus, pitting development is dependent on both alloy composition and electrolyte.

Some other important conclusions can also be drawn from the statistical results. First, to be precise, the critical size of stable pits on 316L SS was $\sim 9\ \mu\text{m}$ rather than $10\ \mu\text{m}$ [18,34]. Moreover, the 7 to $9\ \mu\text{m}$ pits were the fewest and their growth was also the slowest. This was especially noticeable for the FE alloy where no such pits were observed during the long-term immersion. Note that the pits smaller than $1\ \mu\text{m}$ were not counted in the total number of metastable pits due to the decrease in the statistical accuracy resulting from the limited image resolution. The growing rates of both metastable and stable pits are shown in Figure 3d. The metastable pits in both samples rapidly grew with immersion time, but their growth rate in the FE alloy at the initial stage was obviously slower than that in the bare alloy due to the excellent impermeability of the thickened oxide film (Figure 2). As for stable pits, the growing rate was slow on the bare alloy, but it was extremely low at the initial stage and then accelerated on the FE alloy, and a crossover could thus be observed in the later period between the two samples. These results conformed exactly to our models of self-repairability-dominated protection III and impermeability-controlled protection I in Figure 1b. For the former model, the metastable-to-stable transformation rate should decrease with time due to weak impermeability but strong self-repairability, as in case of bare 316L SS in Figure 3e. Considering the latter model, no such trend was observed on the FE alloy. In addition, these two protection mechanisms also differed in the growth rate of pit size. As shown in Figure 3e, the rate of transformation of 1 to $3\ \mu\text{m}$ pits to 3 to $7\ \mu\text{m}$ pits for both samples increased with time, but the growth rate on the bare alloy was much faster than that on the FE alloy. This suggested another feature of self-repairability, that is, sacrificing growth to avoid abrupt stabilization.

in the number of metastable pits rather than the stabilization of individual stable pits. However, the size change of metastable pits is often ignored because of lacking long-term studies on pitting corrosion of stainless steels. Obviously, the increase in the size with immersion time for the bare 316L SS (Figure 3e), considering their comparatively high density and large diameters (1 to 7 μm , close to stable pits), should also contribute to a significant portion of the corrosion current density. The growth of metastable pits is preceded by frequent activation and repassivation events [20]. Thus, the relatively rapid increase in size in the following weeks but an extremely slow rate of transformation to stable pits (Figure 3e), compared with that of FE alloy, probably indicates a high-frequency occurrence of such events as a result of excellent self-repairability of 316L SS during this stage. Moreover, this high frequency together with the reproduction of pits helps disperse the anodic current density of the alloy surface at the open-circuit potential, and greatly reduces the probability of the stabilization of metastable pits.

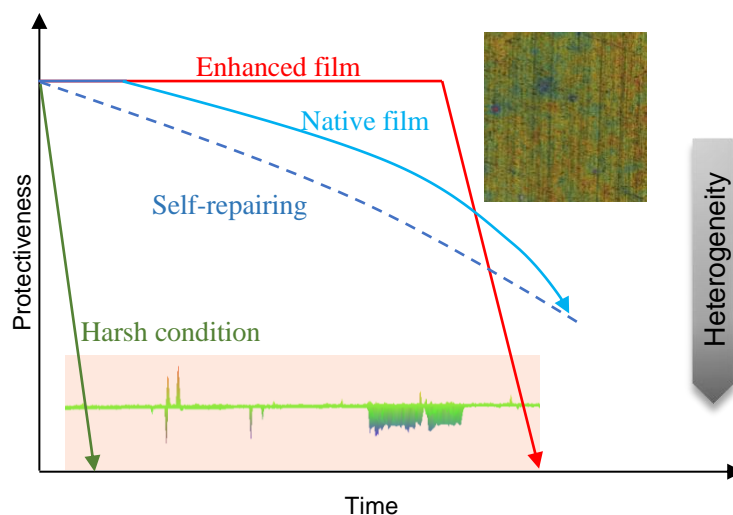
Figure 4. Schematic of critical step for three conditions of pitting: native film without protection under harsh condition (green), native film with excellent self-repairing properties (blue), and the corrosion-resistance enhanced ultrathin oxide film with weak self-repairing properties (red).

It should also be noted that enhanced corrosion resistance at the initial stage was not observed in the 6% FeCl_3 solution, as the oxide film could not survive under such a harsh condition. It was, therefore, assumed that the recovery of the native film would also be impossible, thus the pitting might have rapidly initiated from defects or inclusion sites on the alloy surface in a stabilized way [40]. Meanwhile, the main corrosive behavior changed from the film-related 2-D surface to the bulk-related 1-D hole (see Figure 4), showing a shift to the aggravation of electrochemical heterogeneity, which is irreversible. Therefore, for a superior anti-corrosive alloy, if its native film enables stabilization in a less aggressive electrolyte, the film would be able to resist the ingress of aggressive ions. If the film undergoes a breakdown or a scratch, the rapid repair achieved by forming a dense and inert oxide layer on the alloy surface that is similar to the native film in composition and structure to avoid surface electrochemical heterogeneity, is a more reliable strategy in the long run.
